Geohazard assessment of landslides in south Brazil - Case Study

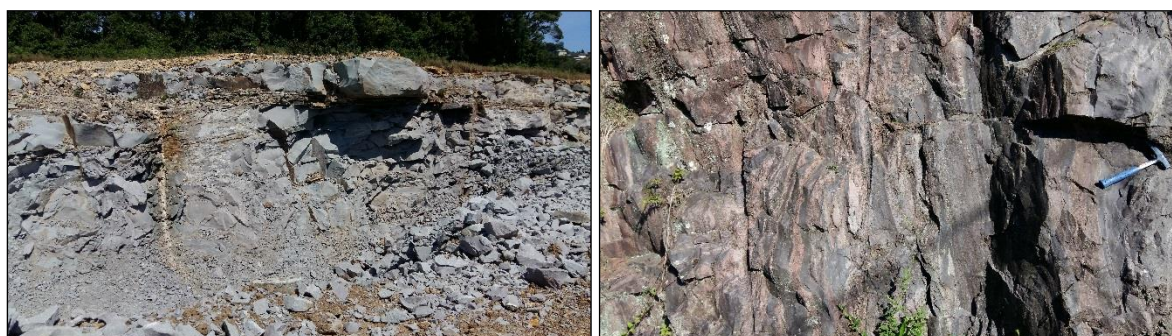
The stratigraphic unit defined as Dacite Canyon usually occurs between heights of 680 and 750 meters. They are acid rocks characterised by vertical flow structures with dark grey to reddish brown colour (**Figure 6**), aphyric texture, plagioclase and pyroxene microphenocrysts, opaque and residual quartz, a matrix of microlites of the same minerals, as well as partially recrystallized glass (Lisboa *et al.*, 2003; Bressani *et al.*, 2005). Locally it fractures parallel to the lamination, with fractures filled by fibrous chalcedony and carbonates.

Fig 5. Dacite Caxias unchanged.

Fig 6. Vertical fault observed in Dacite Caxias.

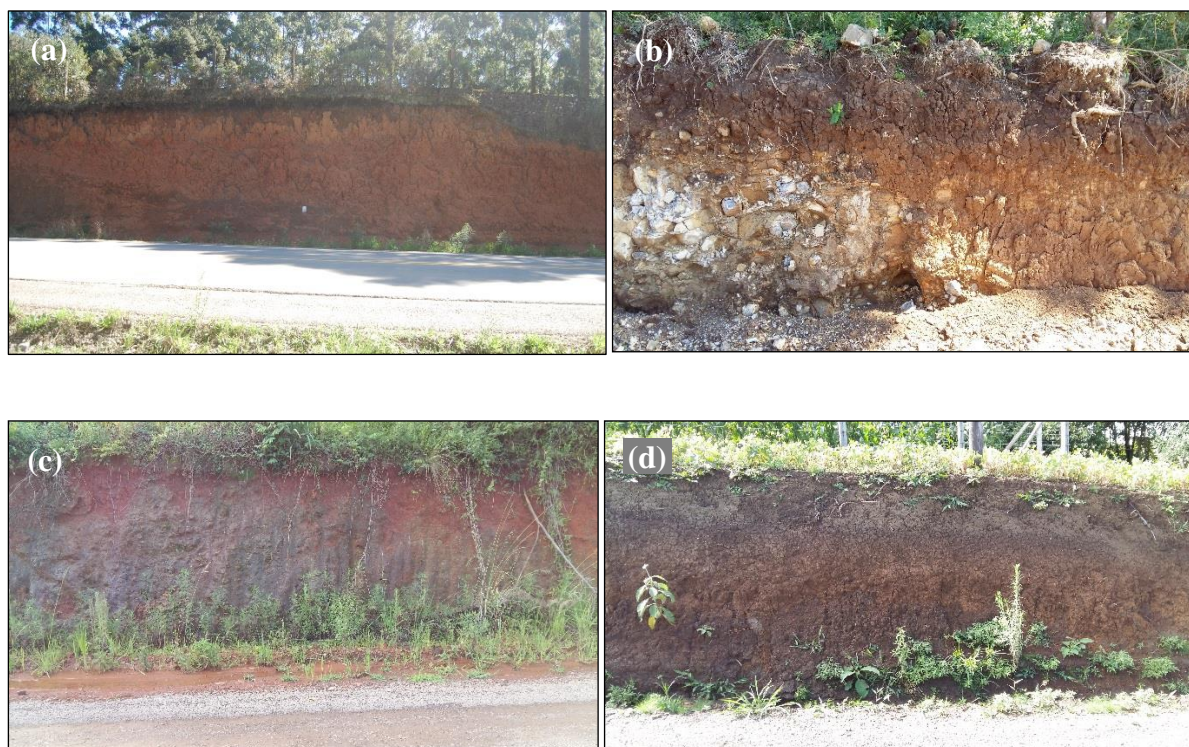
Fig 7. Common types of soils in Caxias do Sul: (a) Forqueta, (b) Caxias, (c) Canyon, and (d) Galópolis.

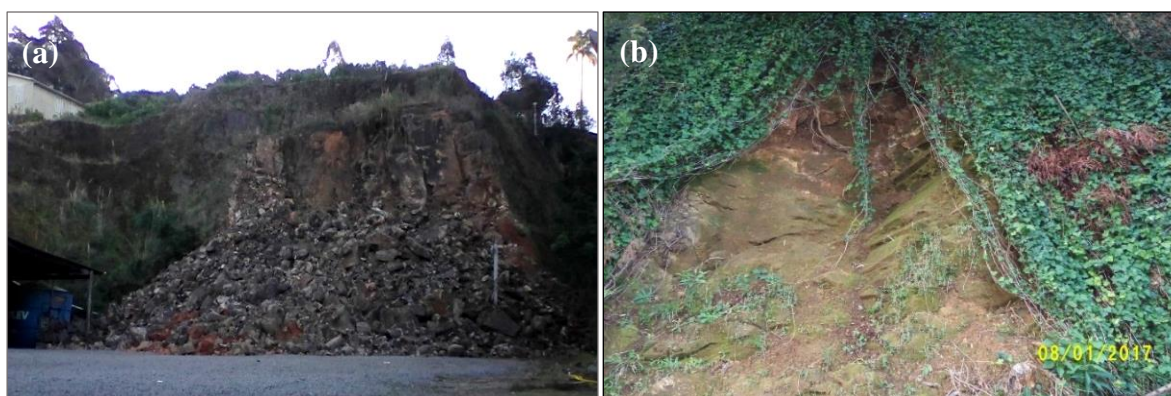
In the city of Caxias do Sul there are only a few records identifying the types of previous mass movements. However, recent evaluations carried out for the city council indicate a predominance of the translational slip process and, more rarely, falls (fractured rocks with conjugate pattern), bearings (blocks of rocks moving in soil matrix), block tipping (**Figure 9-a**) and wedges (**Figure 9-b**). Azambuja et al. (2001) classified two historical cases of mass movements in Caxias do Sul. The first was identified as a conjugate translational movement of a rocky mass according to a discontinuity plane filled with saprolite soil. This slope failure caused damage to a school and seven buildings. This movement was initially identified four years before the incident; the rate of movement increased during the periods of heavy precipitation (Azambuja et al., 2001). The second case was recognised as block tipping, due to the relief of lateral stresses on the slope. The block tipping occurred in the middle and upper part of the slope, which presents saprolite soils and more cohesive materials (Azambuja et al., 2001). Other studies were performed in the urban area and identified the occurrence of falling instability and slope block drop (Pontel et al., 2013, Baiotto et al., 2015).

Fig 9. Two types of slope failure observed in Caxias do Sul: (a) Block tipping
(b) Wedges failure
