Case Studies in Engineering Failure Analysis

Root cause failure analysis of a tracked vehicle balance arm

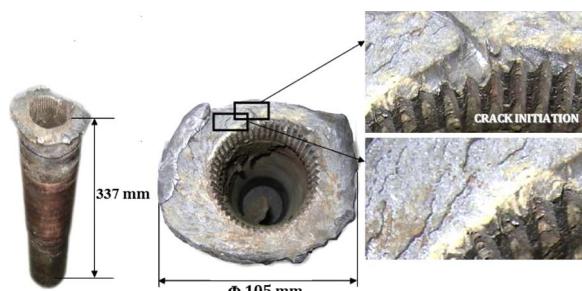
The single fractured balance arm during tracked vehicles disassembly was visually examined to know the probable cause of failure/damage. The fracture surface shown in Fig. 2 was fairly flat with multiple crack initiation points. The cracks initiated from the spline teeth area near the internal diameter. Moreover, the final fast fracture has the typical appearance of brittle fracture. This evidently depicts no or little plastic deformation [11]. Also the Balance arms in general were found with corrosion.

Fig. 2. Fractured balance arm.

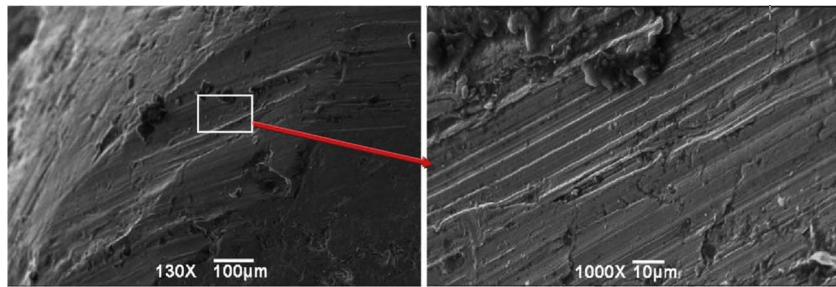
Fig. 3. (a) and (b) Post Failure Damage of the fracture surface.

Micrograph with its magnified counterpart is shown in Fig. 3a and b. The presented micrograph depicts post failure surface mechanical damage.

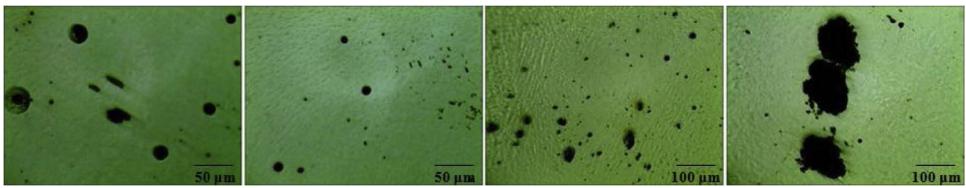
The Optical and SEM micrographs of polished cross-section are shown in Figs. 4 and 5 respectively. These micrographs reveal porosity close to internal bore, midway of the cross-section, close to the internal diameter and near external diameter. These locations are highly prone to develop cracks as fatigue cracks initiate on localized shear plane at or near porosity, inclusions, or discontinuities [12]. It is worth noting that the optical Micrograph presented in Fig. 4d reveal large sized pores of the order of about 100 μm which supports the fact that the cracks have initiated near internal diameter adjacent to bore having spline teeth. Both optical micrographs, SEM micrographs are seen to exhibit substantial porosity in the structure from sub-micron to as large as more than 100 μm . These discontinuities in metallic mass are due to non-metallic inclusions, which cause to reduce the strength, resistance to fatigue, etc. The two dominant inclusions in steel are MnS and Al₂O₃ [13]. During polishing for metallography this type of inclusions are leached out leaving behind pore-type appearance. The inclusions in Balance arm are attributed towards MnS inclusions as unexpectedly high sulphur content was observed during chemical analysis. MnS inclusions are categorized under non metallic inclusions which are detrimental to steels mechanical properties. Presence of MnS impurities leads to an improvement in machinability, however they facilitate crack propagation by acting as void nucleation sites. This indicates manufacturing fault during fabrication i.e. casting [13,14].

Location	Detail
A	Optical image close to internal bore having spline teeth ($\times 500$)
B	Optical image at midway of cross-section ($\times 500$)
C	Optical image close to outer diameter ($\times 200$)
D	Optical image near internal diameter adjacent to bore having spline teeth ($\times 200$)

Fig. 4. Optical micrographs at (a) location A, $\times 500$; (b) location B, $\times 500$; (c) location C, $\times 200$; (d) location D.

- The Balance Arms were seen with corrosion. There must be anti corrosion agents used to minimize corrosion due to environmental conditions.
- Visual examination of Balance arm revealed failure that was observed to be flat having brittle fracture characteristics and multiple crack initiation points. During SEM, post fracture mechanical damage was observed in the micrographs. In addition, substantial porosity of was observed during SEM and optical Microscopy of polished surface. The large size voids observed during SEM and Optical microscopy were attributed to MnS inclusions. This finding was further related to manufacturing fault. To avoid early crack development, the manufacturing procedure needs to be changed.

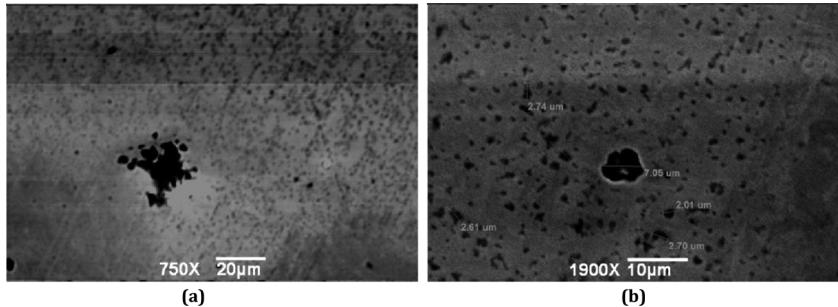
Fig. 5. (a) and (b) SEM micrographs showing porosity at 750 \times and 1900 \times magnification.

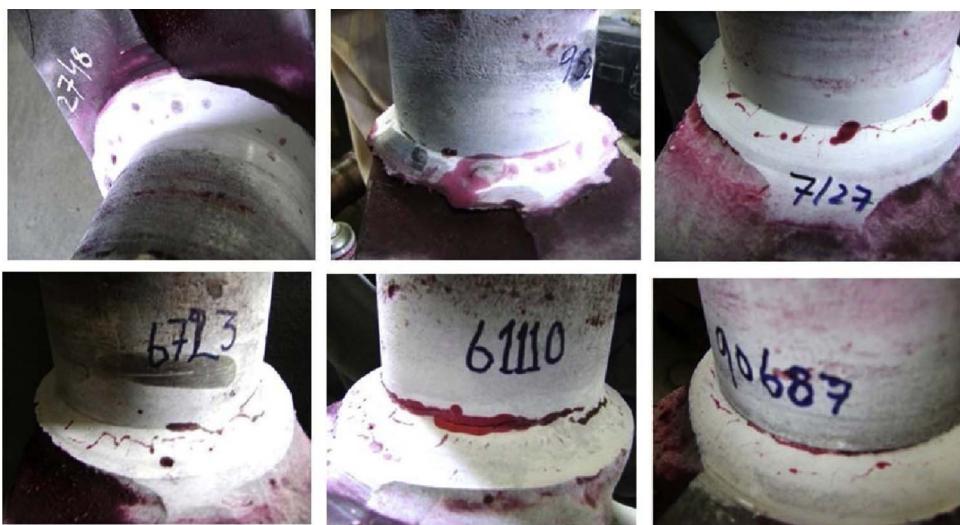
The remaining 3 Arms were found free of cracks. The observed cracks were circumferential in nature and surprisingly all the cracks were seen at the hull side on the lower curvature of the balance arm surface (Fig. 7). The inspected 10 torsion bars, sprocket

S. No.	Location	Crack length (mm)	Defect	Part No
1	On Hull side	5–30	Cracking	2748
2	On Hull side	2–25	Cracking	952
3	On Hull side	5–45	Cracking	7127
4	On Hull side	6–40	Cracking	6723
5	On Hull side	2–20	Cracking	61110
6	On Hull side	6–35	Cracking	90687

Fig. 7. Liquid penetrant tests revealing cracks in various balance arms of the upgraded Tracked vehicle.

- During Liquid penetration technique, 6 arms were observed with significant cracks in the portion fitted inside the hull body of the tracked vehicle. The cracks were along the circumference on the lower semicircular arc of the Balance arm. All the cracks were observed towards the hull side. The third left arm was found fractured. The cracks initiated and propagated along the x-axis. During NDT results post-processing it was found out that the state of stress at the tip of the crack is elastic plain strain, Balance arm is loaded in brittle state. The Balance arm design needs to be modified to reinforce the area where cracks have been identified to initiate.
