## Technical paper: Validation of electrokinetic stabilisation of M5 Junction 7

7 January, 2019

D Alder and J Lamont-Black, Electrokinetic; O Hamza, University of Derby; C Jackson, Jacobs; and C Jones, Newcastle University

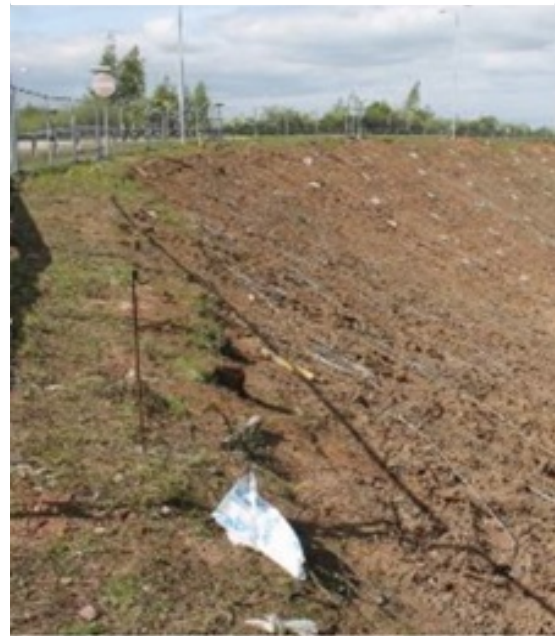
(a) View of M5 J7 embankment during Electrokinetic treatment

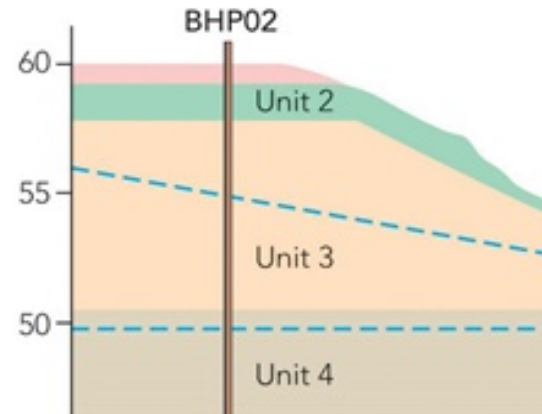
The ground investigation identified the embankment core as reworked firm to stiff weathered Charmouth Mudstone (Lower Lias Clay), which is a highly plastic clay with problematic shrink-swell characteristics, overlain by a mantle of variable soft to firm glacial or terrace deposits identified as reworked Mercia Mudstone (table 1). The underlying geology was the Mercia Mudstone Group (figure 2).

(b) Typical cross section of the slope based on the interpretation of Ground Investigation

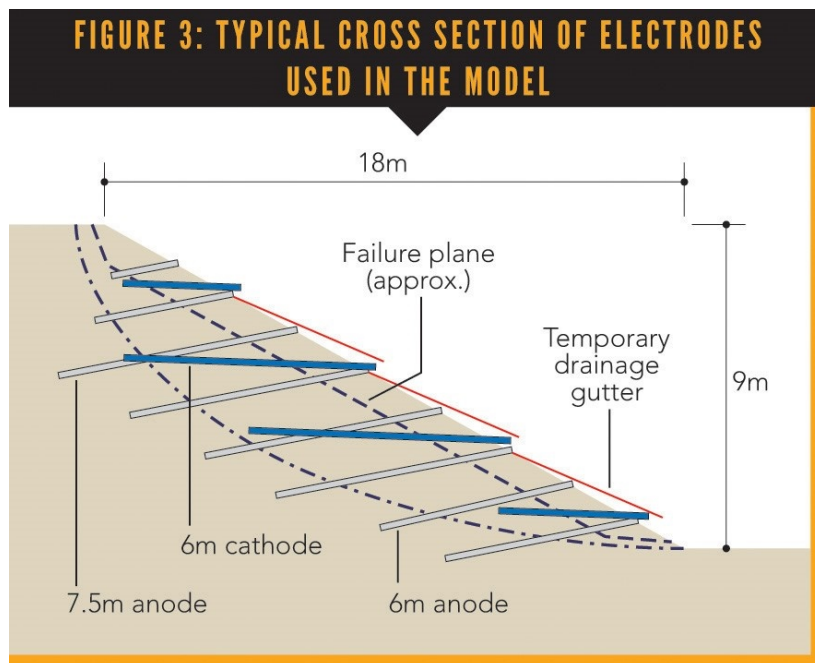
Investigation of the embankment failure mechanism showed that stability could be achieved by effecting an improvement to the shear strength of the materials forming the embankment to a depth of 3m. To cover the potential deep-seated failure mechanism an EK treatment depth (anode length) of 7.5m was required with the cathode (drains) being 6m (figure 3).

The electrodes used to stabilise the slope were installed in columns arranged perpendicular to the slope contours at spacings varying between 1.5m and 2m. A closer spacing of columns equates to a higher voltage gradient (with concomitantly higher treatment intensity) and a higher density of reinforcing and drainage elements. The closer spaced columns were installed in sections of the slope assessed to have the lowest stability. A total of 612 anodes and 308 cathodes were used in the design.

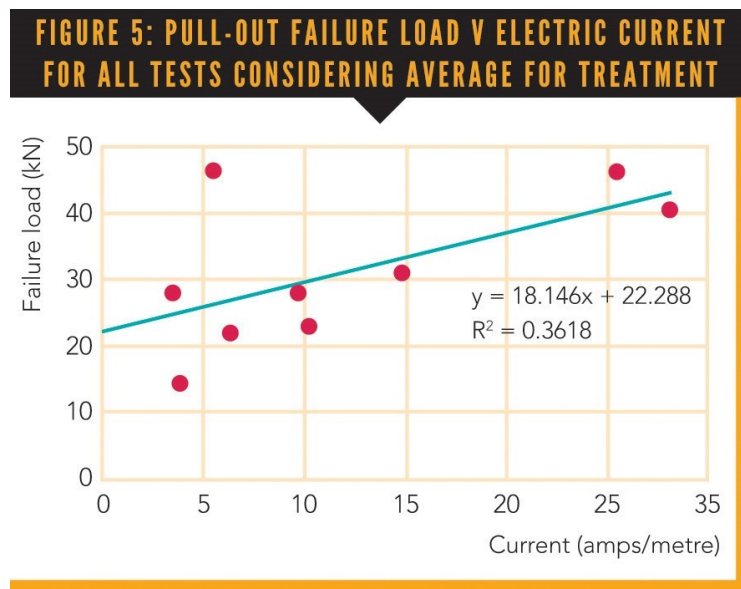
As shown in figure 5 there is a good correlation between the average current per treatment panel and ultimate pull-out resistance developed, such that the lower results are generally at the northern end of the site which comprised drier soil in the shorter shallower slopes. The linear correlation shown in Figure 5 can be expressed as:

Some variation of the pull-out tests results may be attributed to installation issues. An oversized anode drive head was used to install the anode electrodes, which may have limited effective contact between the anode and the stiffer embankment materials. This did not inhibit the dewatering, consolidation and mass strength gain, but did appear to have affected the development of the enhanced cemented bond between the anode and the soil in some locations.

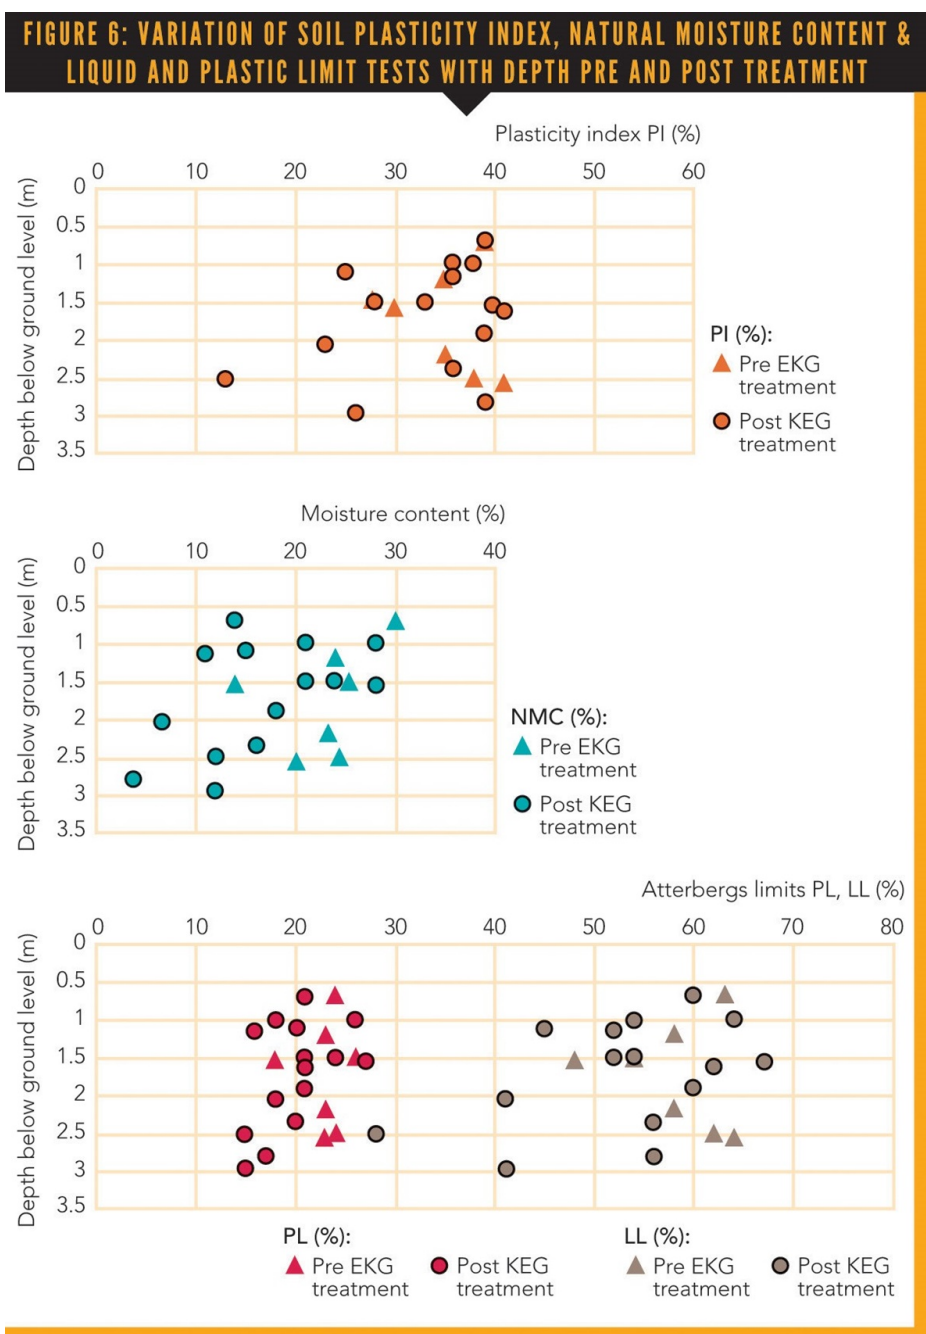
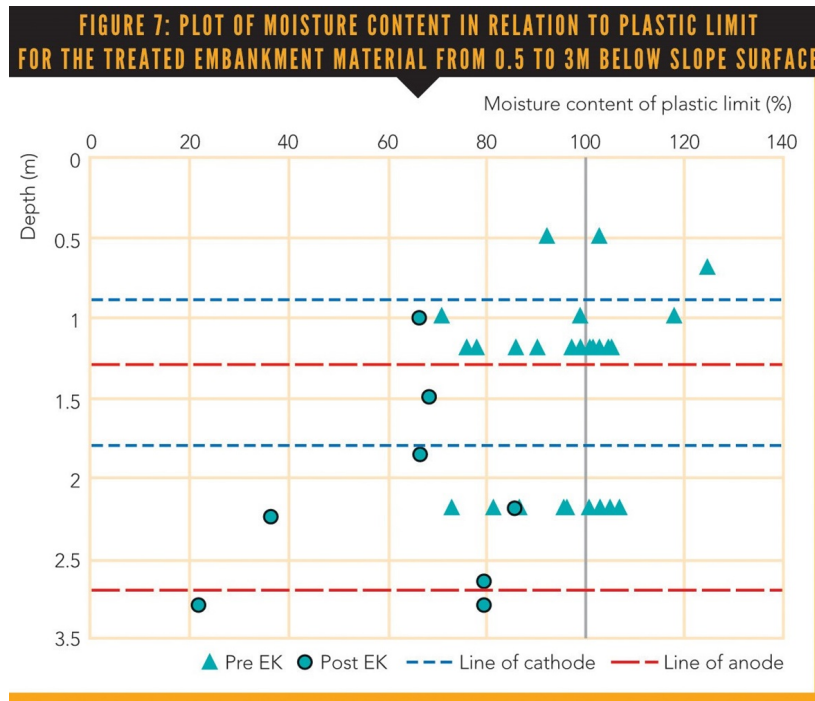
A total of 50 natural moisture content and liquid and plastic limits tests were carried out on samples from the exploratory boreholes at various depths. The results show a general reduction in the moisture contents and liquid and plastic limits in both the reworked Mercia Mudstone and Lias Clay, following EK treatment (figures 6 and 7).

Figure 7 shows the pre-treatment moisture contents lay at or around the corresponding plastic limits, whereas the post-treatment data indicates that the EK treatment reduced the moisture content well below the plastic limit. The reduction in soil plasticity is associated with physio-chemical changes in the soil including cementation, precipitation, and flocculation effects which act together with consolidation and shear strength improvement, (Milligan, 1994; Pugh 2002). Statistical analysis carried out on the data shown in figures 6 and 7 is shown in table 4. The reduction in natural moisture confirms the discharge of water observed during the active treatment period (figure 4).

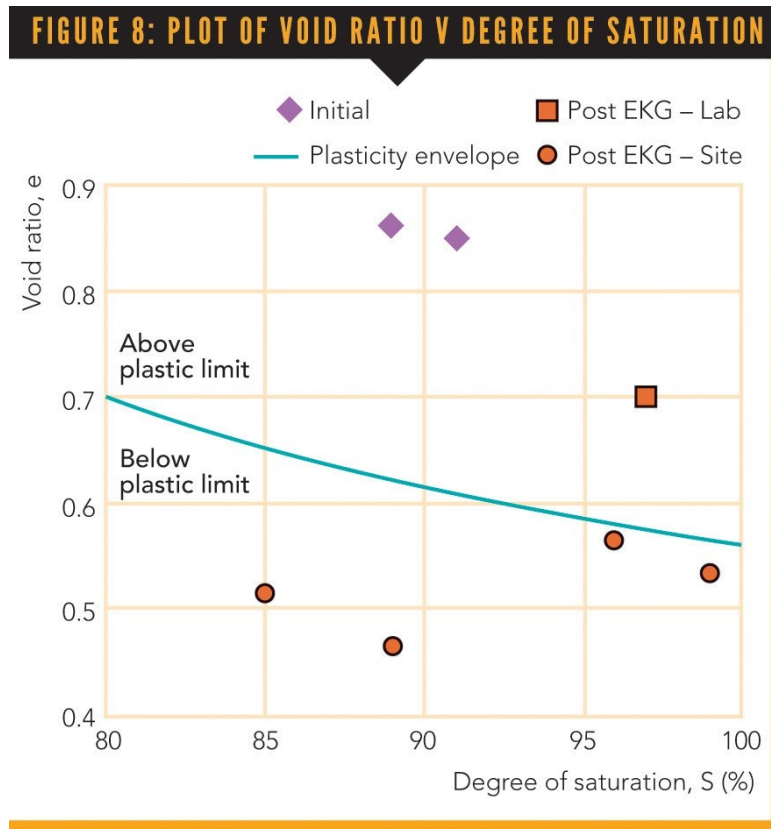
Figure 8 presents the degree of saturation against void ratio for pre and post EKG treatment from the treated area. By assuming a typical specific gravity of 2.7 and taking the mean of the pre and post-treatment plastic limits (21%), a plasticity envelope is defined for differing values of void ratio and degree of saturation.

The post-treatment material lies below the plasticity threshold, whereas the pre-treatment and laboratory treated EKG materials are above. EK treatment produced a marginal increase in the mean value of the degree of saturation, while the mean value of void ratio exhibited a significant decrease of up to 32%.

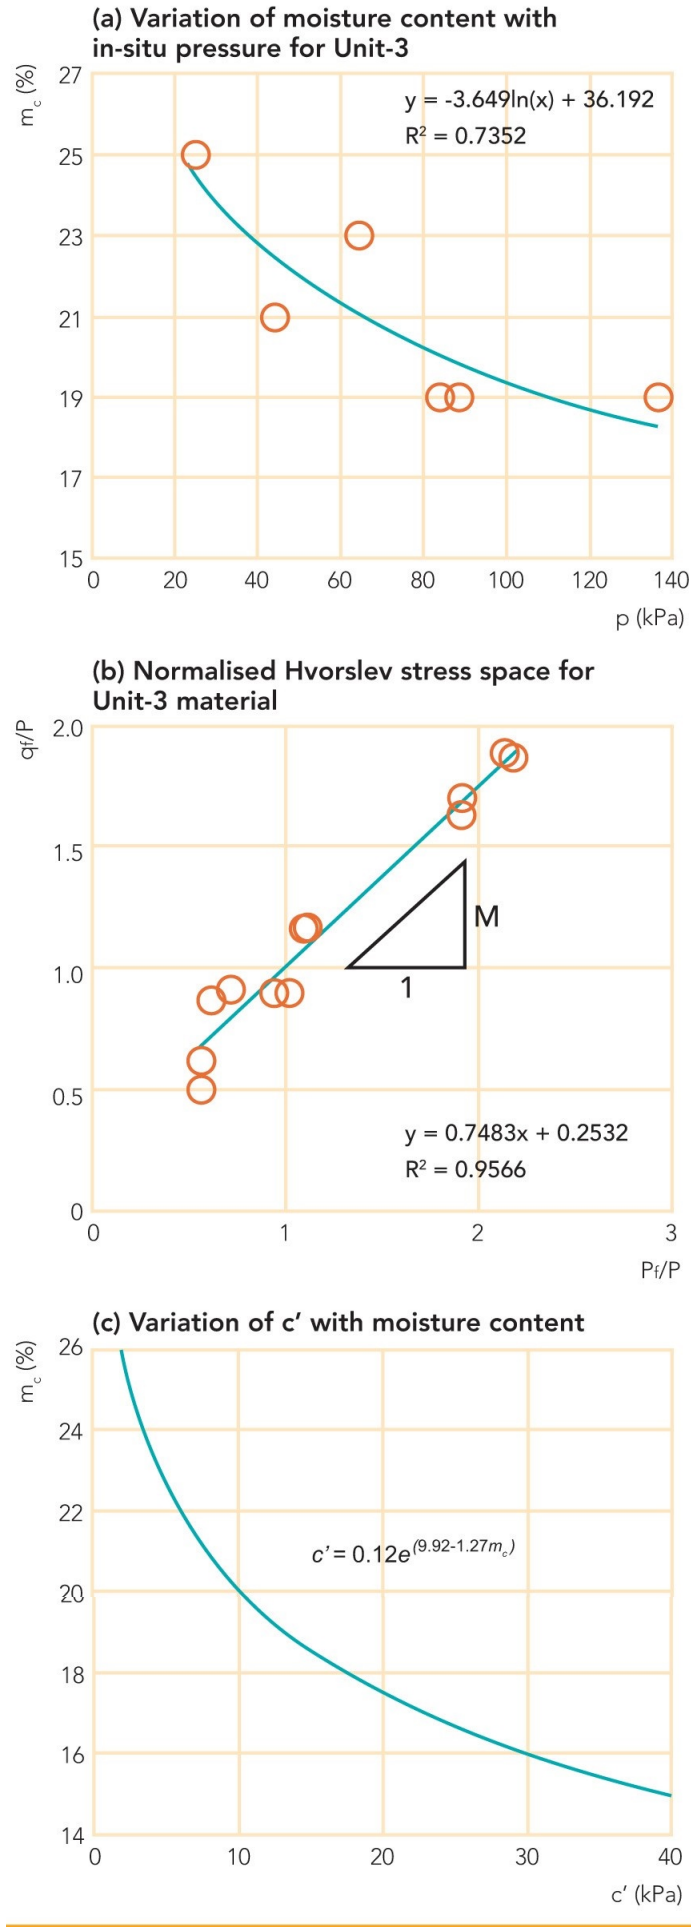
**FIGURE 9**

This procedure has been adopted for the reworked Lias Clay (unit-3). The variation of  $m_c$  with respect to in-situ pressure,  $p$ , is given by the equation (figure 9a):

By substituting equation 6 into equation 3 and rearranging, a unique relationship of drained cohesion with respect to moisture content can be derived (Figure 9c):

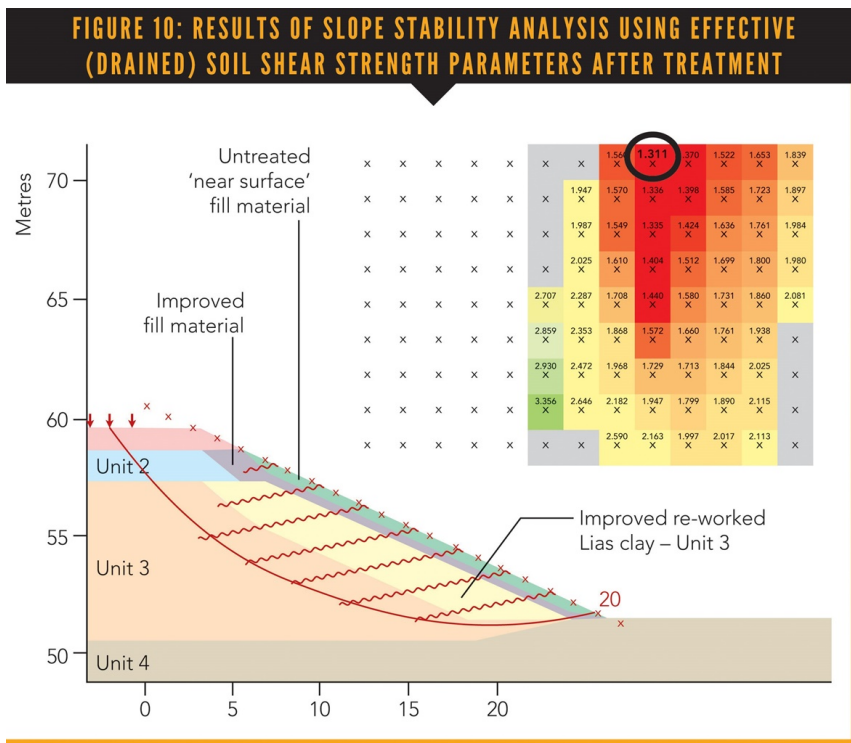
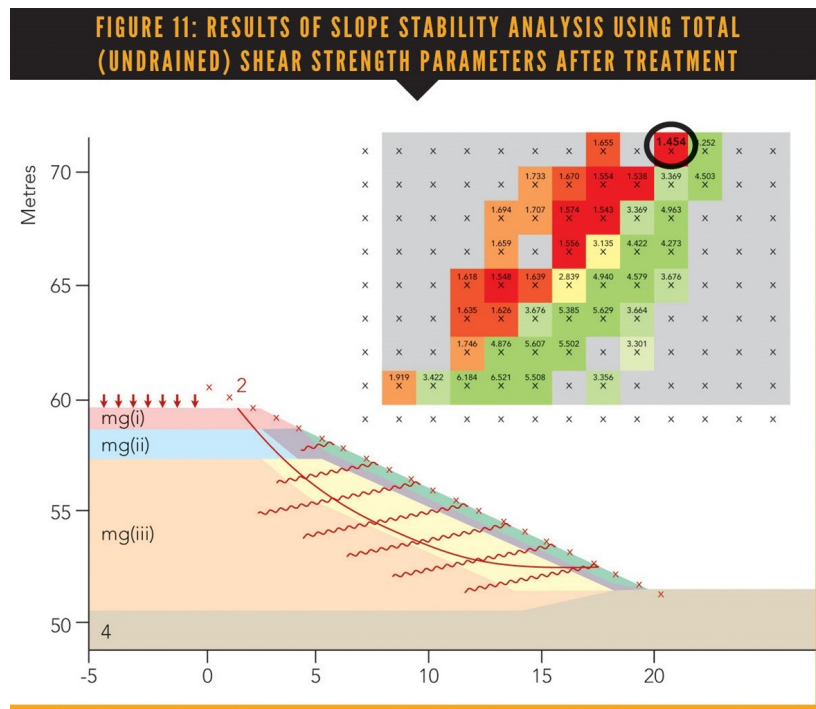
The stability of the embankment was analysed using Slope-12R (Geosolve, 2003). Figures 10 and 11 show the analytical results of a typical section of the embankment using drained and undrained soil parameters respectively, where a minimum FoS above the threshold value of 1.3 required by HA68/94 (Highways Agency 1994), were obtained indicating that the EK treatment had resulted in stabilising the failing embankment.
