Soil-Driven Self-Healing Concrete: Evaluation of Soil Bacteria, Encapsulated Nutrients, and Environmental Conditions

Submitted in partial fulfilment of the requirements for obtaining a Doctor of Philosophy in Civil Engineering from the University of Derby

University of Derby, College of Science and Engineering

February 2025

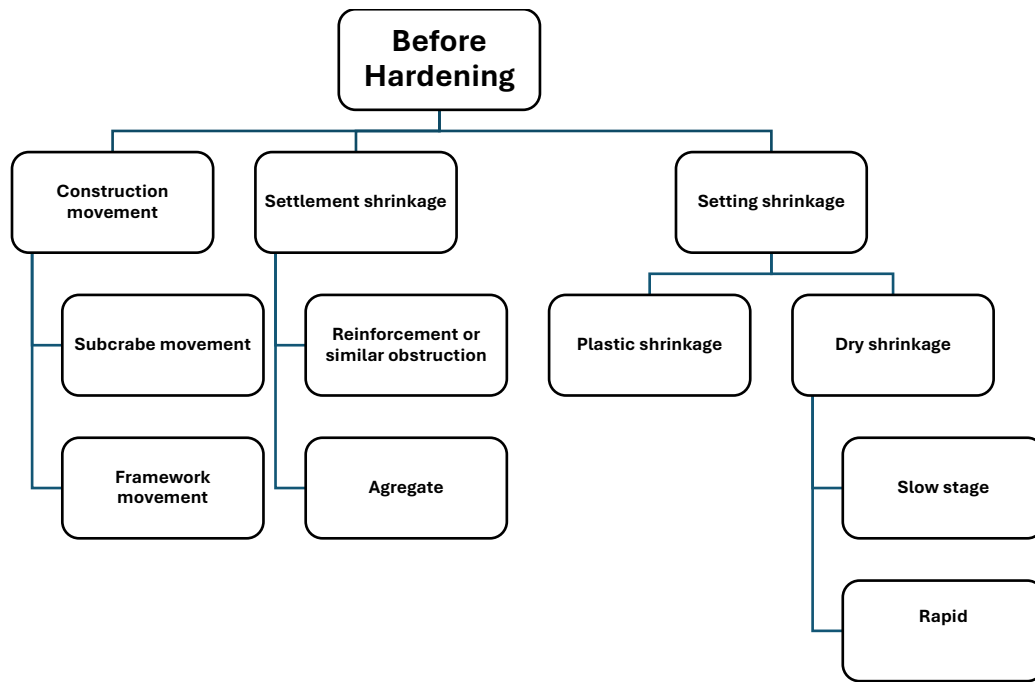
Figure 2: Causes of cracks before hardening adopted form (TR22 Non-structural cracks in concrete 2010)

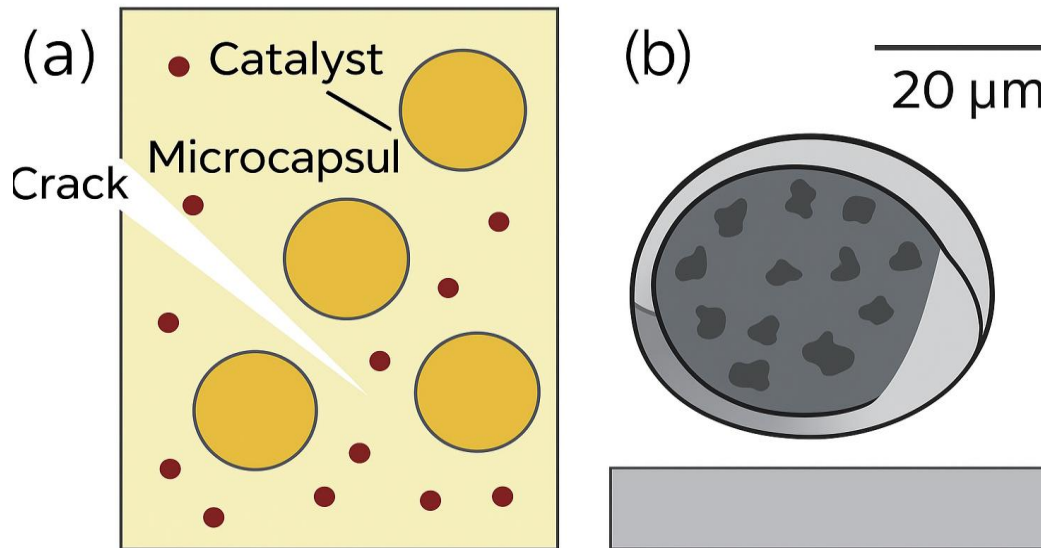
Figure 13: The capsule technology's healing concept is as follows: (a) cracks appear in the matrix. (b) An ESEM image shows a ruptured microcapsule adopted from (White *et al.* 2001).

microcapsules and macrocapsules. The self-healing technique is represented in Figure 13 was adapted and modified from White *et al.* (2001).

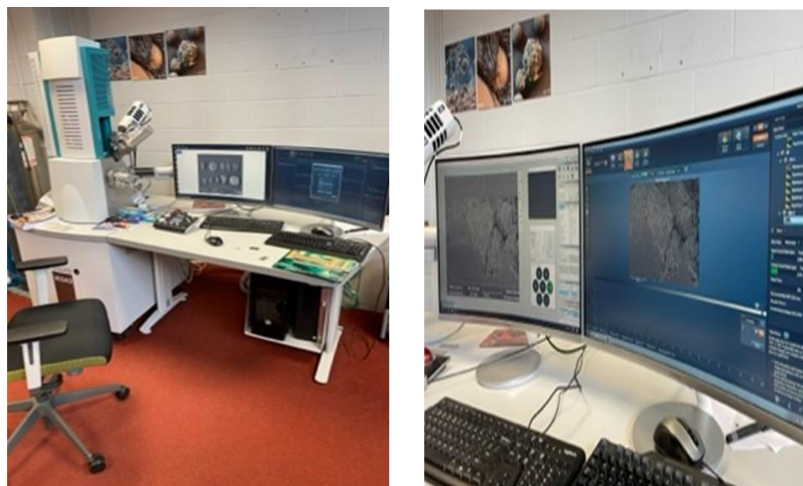
Figure 25: Scanning electron microscopy and energy dispersive X-ray (SEM-EDX)

X-Ray Diffraction (XRD) and Scanning Electron Microscopy (SEM) are selected as primary analytical techniques for characterizing and identifying crystalline phases in cementitious materials as shown in Figure 25. XRD is employed to determine the crystalline structure and phase composition of materials by analysing the diffraction patterns generated when X-rays interact with the crystal lattice, enabling the identification of distinct mineral phases and providing insights into the material's crystallography (Stutzman, Feng and Bullard, 2016). Meanwhile, SEM offers high-resolution imaging of surface morphology and microstructural features, allowing for a detailed examination of particle shapes, surface texture, and elemental distribution when coupled with Energy Dispersive X-ray Spectroscopy (EDS) (Goldstein *et al.*, 2017). This complementary approach facilitates a comprehensive analysis, with XRD providing quantitative phase identification and SEM revealing the microstructural characteristics critical to understanding the material's durability and reactivity in various environments (Goldstein *et al.*, 2017). Together, these methods are integral to a thorough evaluation of crystalline formations in cement-based materials, aiding in assessing their impact on long-term performance.

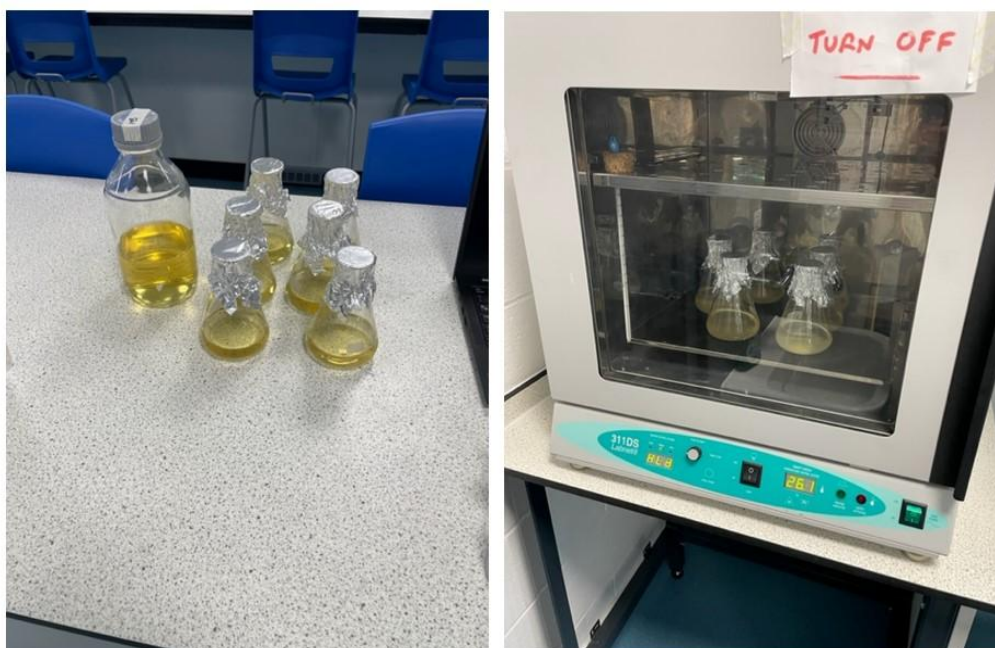
Figure 26: six flasks and shaking incubator

For this study, *Bacillus subtilis* and *Sporosarcina pasteurii* (formerly *Bacillus pasteurii*) were chosen because of their well-known ability to produce calcium carbonate, which helps improve concrete durability and self-healing properties. Figure 26 shows six flasks in an incubator with cultivated bacteria. These bacteria are naturally found in soil and are particularly resilient, making them suitable for surviving in the harsh, high-alkaline environment of concrete. *Bacillus subtilis* is a widely distributed bacterium capable of forming spores, allowing it to endure extreme conditions. *Sporosarcina pasteurii*, on the other hand, is highly efficient in calcium carbonate precipitation due to its strong urease activity. This enzyme breaks down urea, increasing the pH of the surrounding environment and encouraging calcium carbonate to form—an essential process for sealing cracks in concrete. As part of Phase 1, experiments were conducted to test how well these bacteria survived and performed in controlled conditions. The focus was on understanding how pH levels affected their ability to produce calcium carbonate, both in direct bacterial cultures and in a separate experiment that examined calcium carbonate formation in solution at different pH values. These tests provided valuable insights into the ideal conditions for microbial mineralization, helping to refine the approach for integrating bacteria into self-healing concrete systems. *Bacillus subtilis*, a gram-positive bacterium, is notable for its resilience and capability to form endospores, allowing it to endure harsh conditions, including the alkaline environment typical of concrete. When integrated into the concrete matrix, *B. subtilis* engages in metabolic processes that lead to the precipitation of calcium carbonate (CaCO_3), effectively filling cracks and voids (Wang *et al.*, no date b). The formation of CaCO_3 not only seals these imperfections but also enhances the overall mechanical strength of the concrete. The effectiveness of these bacteria in enhancing self-healing capabilities is also significantly influenced by environmental factors, especially pH levels. The pH of the concrete environment plays a critical role in determining bacterial activity and metabolic functions. Generally, both *B. subtilis* and *B. pasteurii* thrive within an optimal pH range of 7 to 9, which aligns with the alkaline conditions found in concrete (Zeigler and Perkins, 2021). Lower pH levels can negatively impact the viability and metabolic processes of these bacteria, leading to decreased effectiveness in facilitating calcite precipitation. On the other hand, excessively high pH levels can also hinder bacterial activity due to heightened alkalinity, creating an unfavourable environment for metabolic functions (Shrestha *et al.*, 2022).

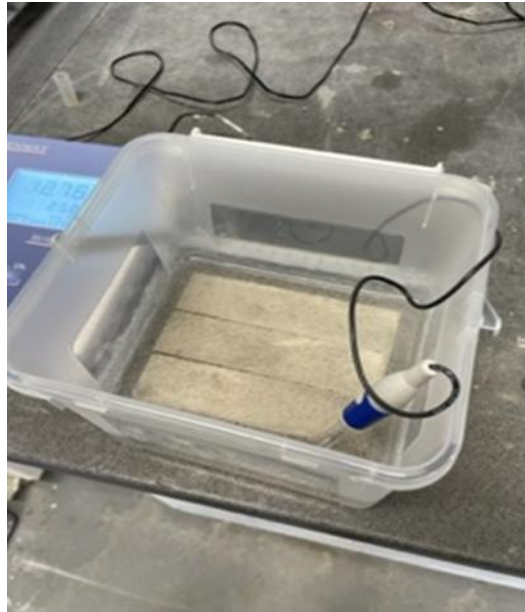
Figure 33: Prisms inside the containers

Three identical 5-liter plastic containers were employed in this study. Each container was filled with tap water up to a 1-liter volume, sufficient to ensure complete submersion of the prisms. Nine mortar prisms, uniform in size and composition, were evenly distributed among the three containers, as illustrated in Figure 33. A calibrated pH probe was used to monitor the solution's pH throughout the 28-day immersion period.

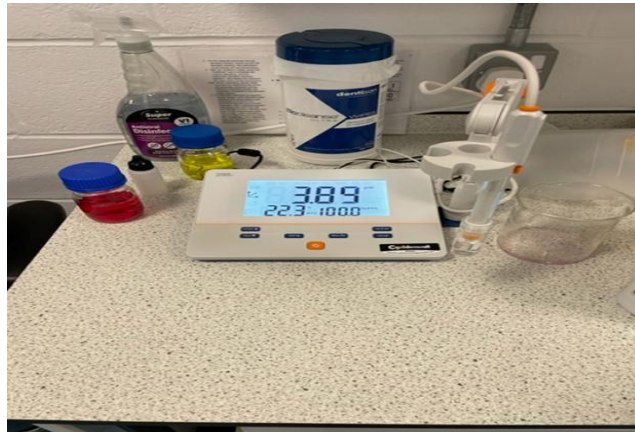
Figure 34: pH meter

In this experiment, a culture of *Bacillus subtilis* was used alongside a growth medium containing urea and calcium chloride (CaCl_2) as the calcium ion source. Hydrochloric acid (HCl) and sodium hydroxide (NaOH) were utilized to achieve precise pH adjustments. The experimental setup comprised a pH meter, six flasks placed in a temperature-controlled shaking incubator. Figure 34 shows the pH meter used in the experiment.

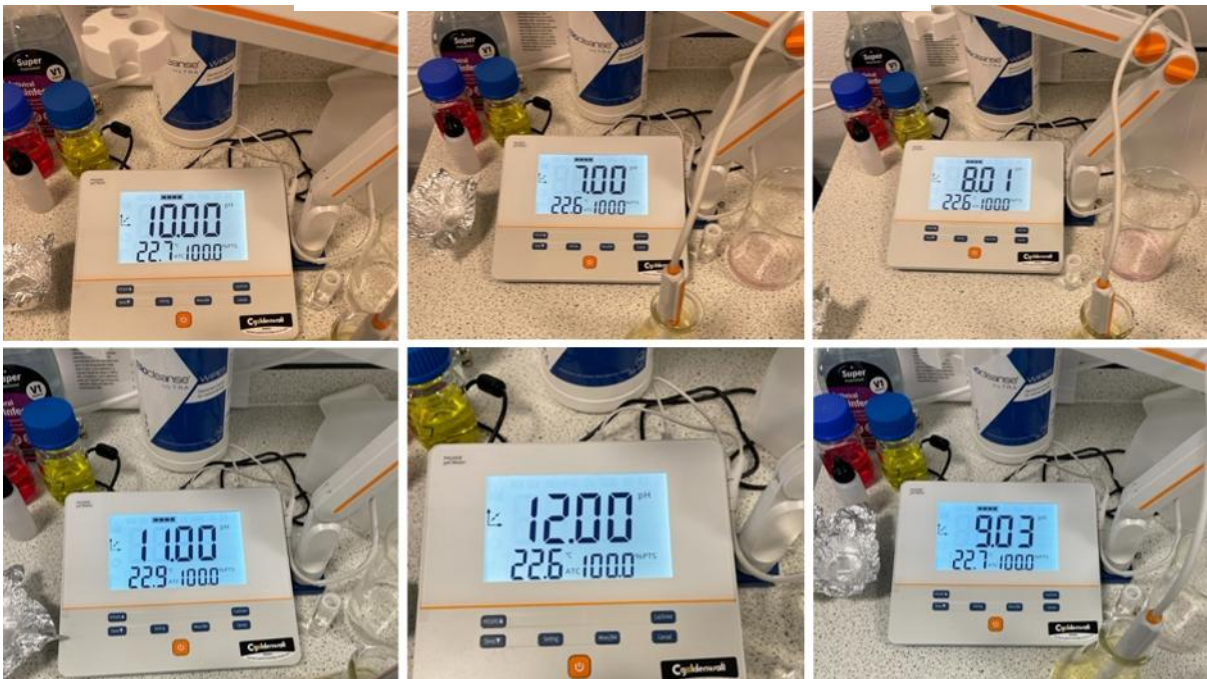
Figure 36: Flasks with different pH value

The preparation of the bacterial culture commenced with formulating the growth medium by dissolving nutrient broth, urea, and ammonium chloride in distilled water, at respective concentrations of 5 g/L, 10 g/L, and 1 g/L. This solution was then sterilized via autoclaving at 121 °C for 15 minutes. Following sterilization, *Bacillus subtilis* was inoculated into the medium, which was subsequently incubated under controlled conditions in a shaking incubator at a temperature range of 30-37 °C and a shaking speed of 150-200 rpm. After incubation, the sterile growth medium was aliquoted into individual flasks. Using a pH meter, the pH of each flask was measured and adjusted to target values of 7, 8, 9, 10, 11, and 12 by adding HCl or NaOH, as illustrated in Figure 35. Calcium chloride was subsequently added to each flask to achieve the intended calcium ion concentration. In the subsequent phase, an equal volume of cultured *Bacillus subtilis*, comprising 10% of each flask's total volume, was introduced to the pH-adjusted flasks. These flasks were then returned to the shaking incubator, set to the same conditions of 30-37 °C and 150-200 rpm, and incubated for a period of 7 days, as shown in Figure 36.

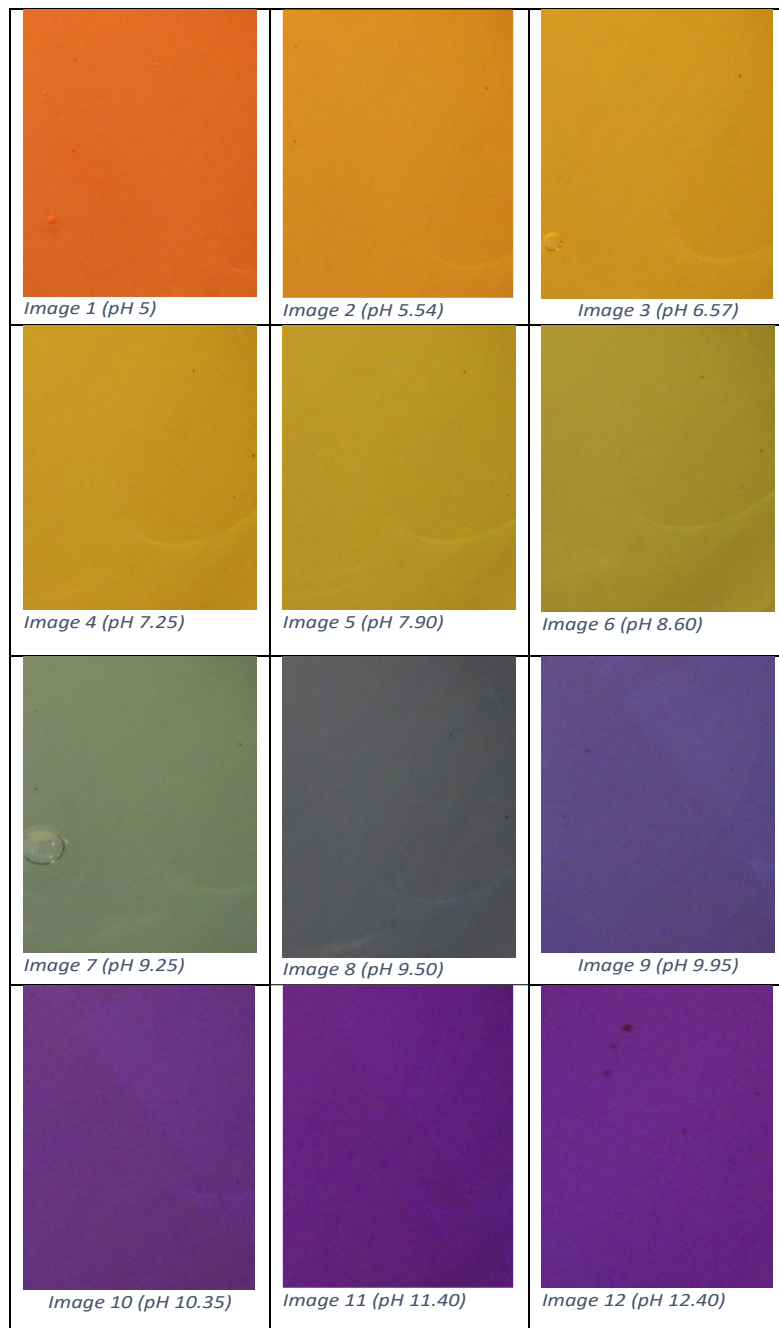
Figure 50: pH value with different image colour

The universal indicator covers a much broader pH range and shows more distinct colour transitions compared to phenolphthalein, as shown in Figure 50 and table 8. While phenolphthalein only changes from colourless to light or dark purple within a narrower pH range of approximately 8 to 14, the universal indicator provides clearer distinctions across a wider range. The images below illustrate the gradual colour changes that occurred with each addition of sodium hydroxide. With the universal indicator, even the first image, which represents carbonated water as the starting point, shows a visible pH change through a colour shift. Each step from pH 5 to 10 resulted in a distinct colour change, making it easy to differentiate between levels. However, at pH values above 10, the colour remained stable, as seen in images 10, 11, and 12. These images were analysed using ImageJ software to measure the percentages of red and blue in the solution. The colour transitions closely followed changes in pH, and Equations 6 and 7 were used to quantify this relationship. In images 1 to 3, the blue percentage fluctuated slightly due to a lower average blue intensity. However, from images 4 to 12, a clear pattern emerged: as the pH increased, so did the blue percentage, highlighting a strong correlation between pH and colour intensity. In contrast, the red and green percentages did not follow a

clear pattern with pH changes. Both started at higher values but gradually decreased as the solution's colour shifted to purple. For example, in images 1 to 5, the red and green values were initially high but dropped as the pH increased, reflecting the visible transition to a purple hue. Figure 51 illustrates the relationship between pH values and the red, green, and blue percentage values.

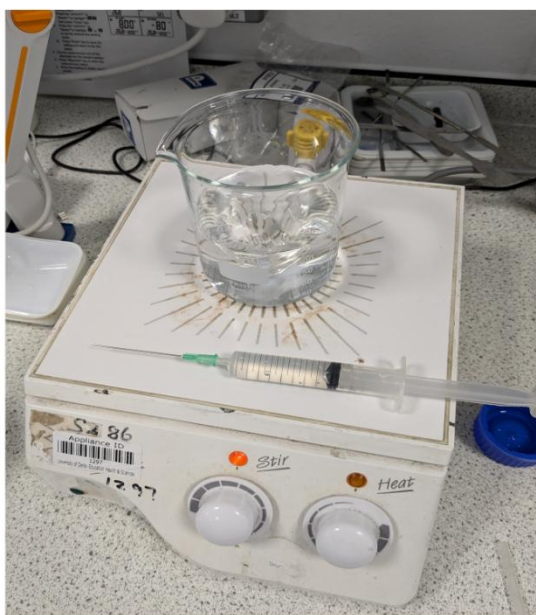
Figure 66: Stirrer for dissolving sodium alginate

Figures 66 and 67 illustrate the formation of microcapsules and the measurement of calcium alginate, respectively. The encapsulation of calcium lactate within sodium alginate microcapsules is a method specifically designed to enhance the self-healing properties of concrete. The process commences with the preparation of a 0.5% sodium alginate solution, achieved by dissolving 0.5 grams of sodium alginate in 100 millilitres of deionized water. Calcium lactate, at a concentration of 1–2% by weight of the alginate, is then added to ensure its incorporation within the microcapsules (Mousa *et al.*, 2021). To enable visual tracking, a small amount of Methylene Blue (0.01%) is mixed in, ensuring it does not affect the capsules' properties. Next, a calcium chloride solution (0.55–1.1 g of calcium chloride in 100 mL of deionized water) is prepared to act as the crosslinking agent. Using a syringe with a fine 30-gauge needle, droplets of the sodium alginate solution—containing calcium lactate and Methylene Blue—are gently introduced into the calcium chloride solution. These droplets immediately begin to gel, encapsulating the nutrients within the alginate matrix. The mixture is stirred lightly (50–100 rpm) for 10–30 minutes to ensure stable microcapsule formation. Once the crosslinking is complete, the capsules are filtered using a Buchner funnel and vacuum filtration system. They are washed thoroughly with deionized water (3–5 times) to remove any residual calcium chloride or unreacted substances. The cleaned microcapsules are then dried either by air for 24–48 hours or in an oven at 40–60°C for 12–24 hours, achieving the ideal moisture content. Finally, the size and uniformity of the microcapsules are examined under a microscope, ensuring they measure approximately 50 μm —an optimal size for integration into self-healing concrete (Meraz *et al.*, 2023). Maintaining the calcium lactate concentration within the alginate shell is vital for successful encapsulation while preserving the integrity of the gelation process (Zadeike *et al.*, 2024).

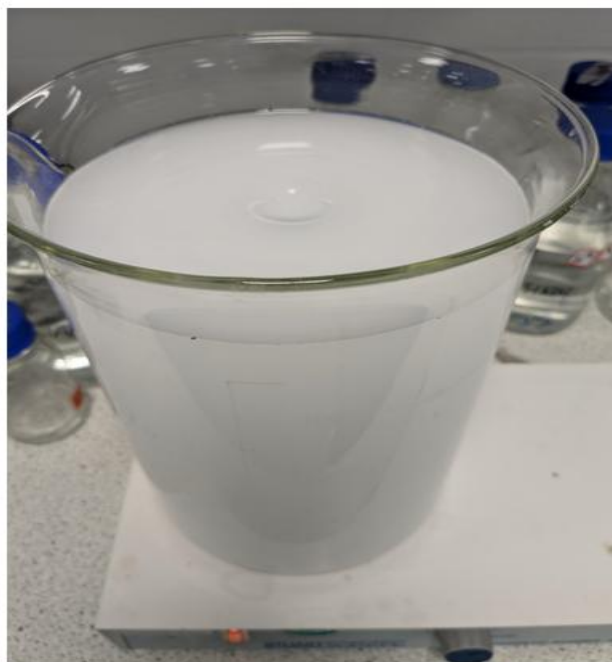
Figure 69: Ingredients and Proportions for Capsule Preparation

Preparing microcapsules to encapsulate calcium lactate involves a series of well-planned steps to ensure they function effectively. The process begins by making a 0.1 M calcium chloride (CaCl_2) solution by dissolving 55.5 g of CaCl_2 in 5 liters of deionized water as showing in figure 69, providing the necessary calcium ions. At the same time, a sodium carbonate (Na_2CO_3) solution of the same concentration is prepared by dissolving 53 g of Na_2CO_3 in 5 liters of deionized water, which acts as the carbonate source for forming calcium carbonate. Next, 0.545 g of calcium lactate is added to the calcium chloride solution to serve as the nutrient for encapsulation, and the solution is stirred to mix it evenly. A small amount of methylene blue (0.32 g in 100 mL of deionized water) is then introduced to the mixture as a tracer to track the

capsules without affecting their performance. The sodium carbonate solution is added drop by drop into the calcium chloride-calcium lactate mixture at a steady pace of 1–2 drops per second. This controlled addition ensures the microcapsules grow uniformly and minimizes the formation of smaller, unwanted particles. Stirring is kept slow (100–200 rpm) to prevent high shear forces from damaging the developing capsules. The mixture is left to stir gently for 2–4 hours, allowing the capsules to grow and stabilize to an ideal size of about 50 μm . Once the capsules have formed, the solution is left to settle for 10–15 minutes before being filtered using a vacuum setup to collect them. The capsules are washed 3–5 times with deionized water to remove any leftover chemicals or byproducts, ensuring they are clean and ready for use. Finally, the capsules are dried, either by leaving them at room temperature for 24–48 hours or using an oven set to 40–60°C for 12–24 hours. This careful drying step ensures the capsules remain intact and ready for integration into self-healing concrete.

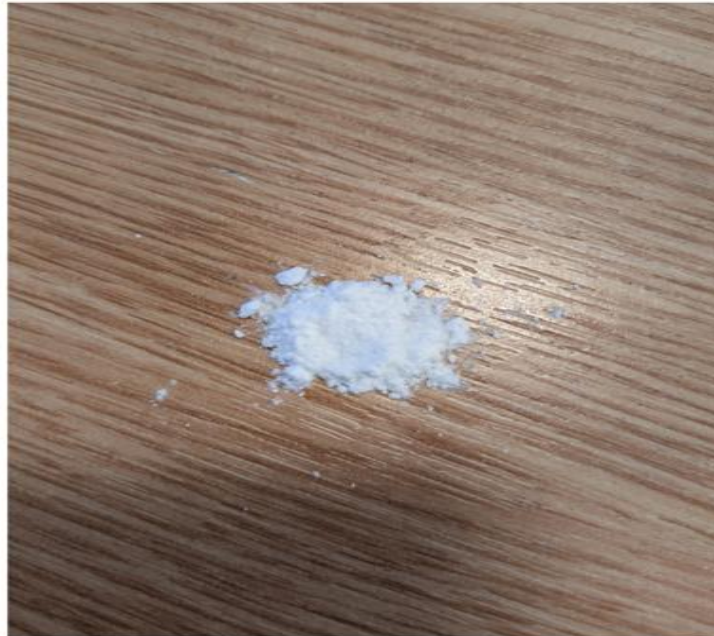
Figure 70: Calcium carbonate capsules

The image in figure 70 shows how calcium carbonate capsules can often look like powder because of their tiny particle size and the way they are processed and dispersed. On a microscopic level, these small particles tend to stick together, giving them a fine and indistinct appearance rather than looking like clearly defined capsules. This is especially noticeable because the capsules are designed with thin shells that break open when concrete cracks, releasing nutrients that activate bacteria and support the self-healing process. Calcium carbonate's natural properties also play a role in its powder-like appearance. Its low solubility, fine crystalline structure, and tendency to exist as micro- or nano-sized particles make it hard to distinguish from powder, even when encapsulation is done successfully. Additionally, calcium carbonate is often ground into ultra-fine particles to improve its performance as a filler in cement systems, which boosts its compatibility but further contributes to its powder-like appearance, even under a microscope. Encapsulating materials at such a fine scale comes with its own set of challenges. The tiny particles tend to clump together, the delicate shells of the capsules are prone to damage, and the mixing process can add extra stress, often making the

capsules look like powder. Despite this, the design ensures that the capsules break open when cracks form, releasing nutrients to activate bacteria and support the self-healing process. Tackling these challenges is key to refining the encapsulation process and making calcium carbonate even more effective in concrete and similar materials.

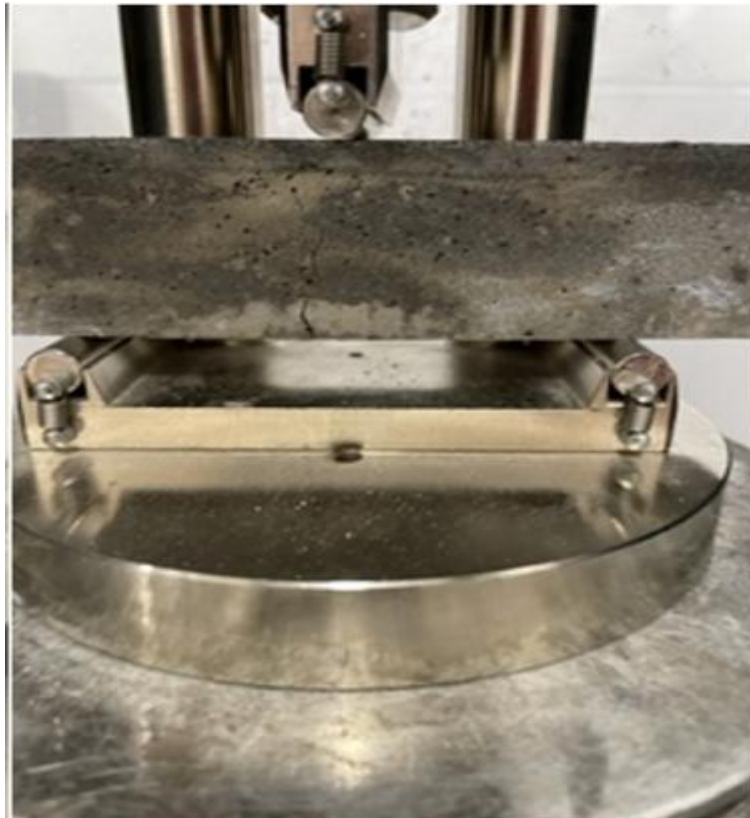
Figure 76: Three-bending testing for generating the crack.

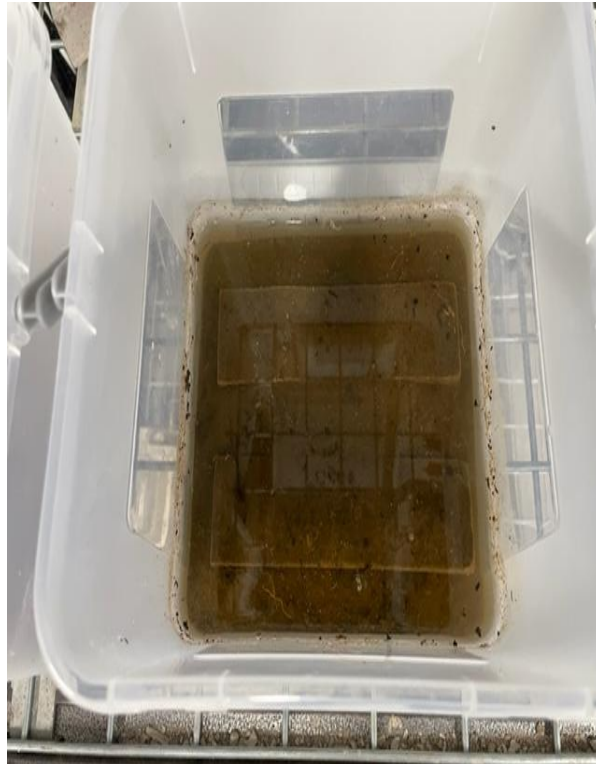
Figure 77: Prisms covered with fully saturated soil inside the containers

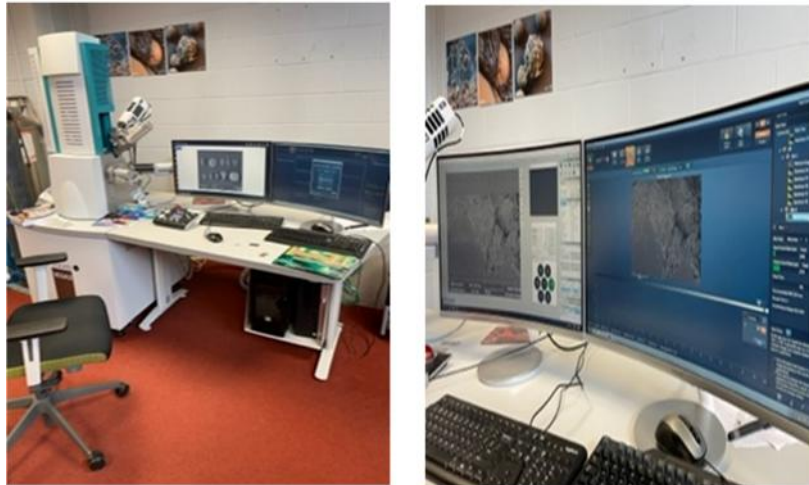
Figure 79: Scanning electron microscopy and energy dispersive X-ray (SEM-EDX).

SEM combined with EDX is a powerful technique used to examine the fine details of soil, allowing us to explore its surface features, elemental composition, and particle structure, as shown in Figure 79. Surface Morphology: SEM provides clear, high-resolution images that reveal the size, shape, and surface characteristics of soil particles. Microstructure Analysis: It also helps us understand the arrangement of soil aggregates, pore structures, and the way soil components are organized. Elemental Composition: With EDX, we can identify and measure the elements present in the soil. This technique detects the X-rays emitted when the sample is bombarded with electrons in the SEM, and it also maps how the elements are distributed within the sample, offering insight into the soil's elemental makeup and variation.

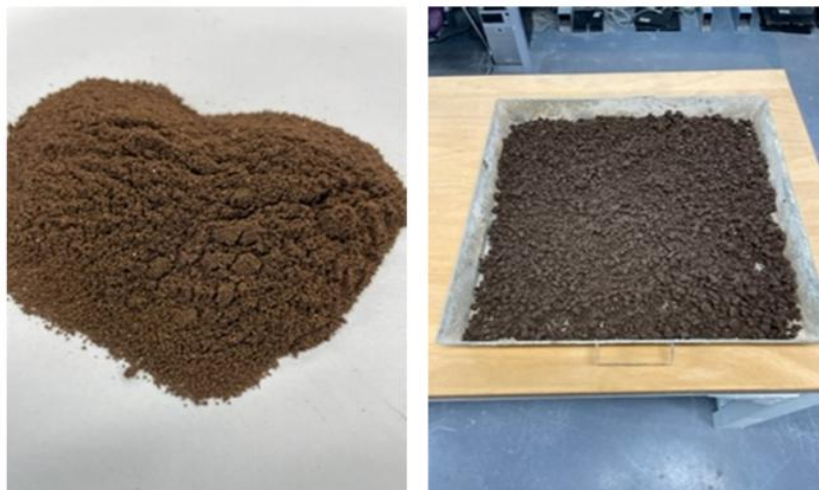
Figure 80: The soil, following the processes of drying and crashing.

For this study, a soil sample was prepared to analyse its components. As shown in Figure 80, the sample was first dried and crushed before being prepared for scanning electron microscopy (SEM). To ensure proper adhesion for imaging, we applied carbon adhesive tape to a stud and gently sprinkled the dried clay sample onto the surface. Excess clay was carefully removed using a fan or pump, and the stud was coated with gold/platinum before being placed under the SEM for analysis ('Chapter 7 GUIDELINE SAMPLE PREPARATION', 2019). When preparing clay samples for X-ray Diffraction (XRD), The clay samples are carefully thinned to approximately 1–2 millimetres, and the surface intended for X-ray exposure is meticulously polished to ensure accurate analytical results. Without proper polishing, surface irregularities may introduce distortions that compromise the reliability of the data obtained ('Chapter 7 GUIDELINE SAMPLE PREPARATION', 2019). SEM and EDX together are excellent tools for analysing soil. SEM's high-resolution imaging gives us a detailed look at the soil particles, including their size, shape, and surface features, while also helping to examine the soil's structure and how the elements are arranged. In this study, SEM and EDX were also used to examine the precipitated material (healing products), allowing us to investigate their crystalline structure and chemical composition. This technique is particularly useful for confirming the chemical makeup of the self-healing products, ensuring we understand how the concrete repairs itself.

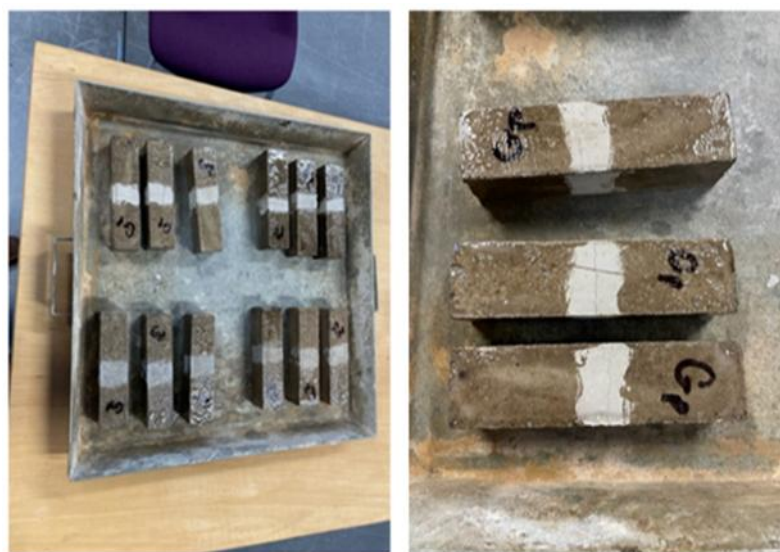
Figure 81: Mortar coating with epoxy

Capillary rise is a common occurrence during the life cycle of cement-based materials (CBMs). In environments where groundwater contains harmful substances like chloride ions, sulphates, and carbon dioxide, capillary action can carry these aggressive agents into the material. This transport of harmful elements through capillary rise leads to the degradation of the CBM matrix and the corrosion of the reinforcing steel bars embedded in it (Bellegheem *et al.*, 2016). The water absorption test is a simple, non-destructive method used to assess how impermeable cement-based materials are, by measuring their ability to prevent water penetration both before and after cracks form (Martys *et al.*, 1997). This process relies on capillary action, which happens due to differences in surface tension between the material and water (Hartland, 2004). In this study, cracked mortar prisms were first dried in an oven at 100°C for at least a week until their weight stabilized, with only a 0.2% change. To prevent water from soaking into the sides, epoxy resin was applied, leaving just a small, exposed area around the crack at the bottom of the prism, as shown in Figure 81. The weight of each specimen was recorded at the start of the test. The specimen was then placed on plastic strips in a tray with a slightly open lid to limit airflow, as shown in Figure 82. The tray was filled with distilled water, ensuring the specimen's face was submerged about 2 mm above the plastic strips. To measure how much water the specimens absorbed, an electronic balance, accurate to 0.01 grams, was used to weigh them before and after the incubation period, as shown in Figure 82. Before weighing, any surface moisture was wiped off with a damp cloth to ensure accurate measurements. Water uptake was measured at intervals of 30 minutes, 1 hour, 2 hours, 3 hours, and 24 hours. The process continued until the specimen reached a stable weight, referred to as W2. The percentage of water absorption was then calculated using the formula:

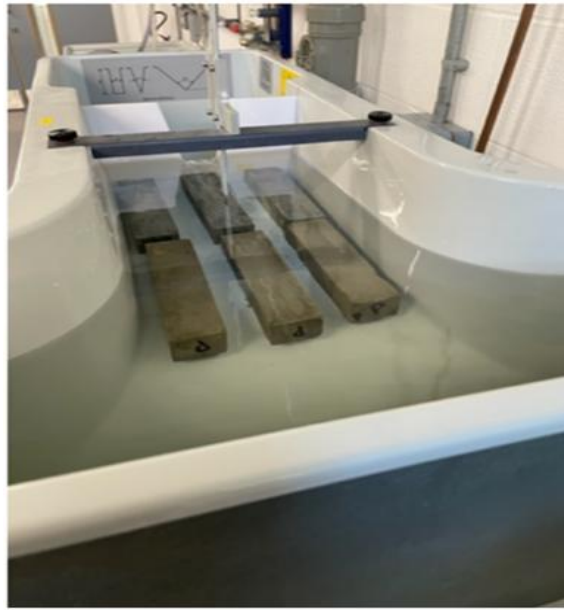
Figure 91: Digital hydraulic bench with prisms positioned within the setup.

The specimens were prepared, and cracks were introduced using well-established methods from previous studies to ensure consistency across all samples. For the flowing water test, a digital hydraulic bench was used to precisely control the water flow conditions. The bench was set to deliver a flow rate of 17.7 liters per minute at a working pressure of 0.295 MPa. Nine mortar prisms were arranged vertically on the bench with equal spacing between them, as shown in Figure 91.

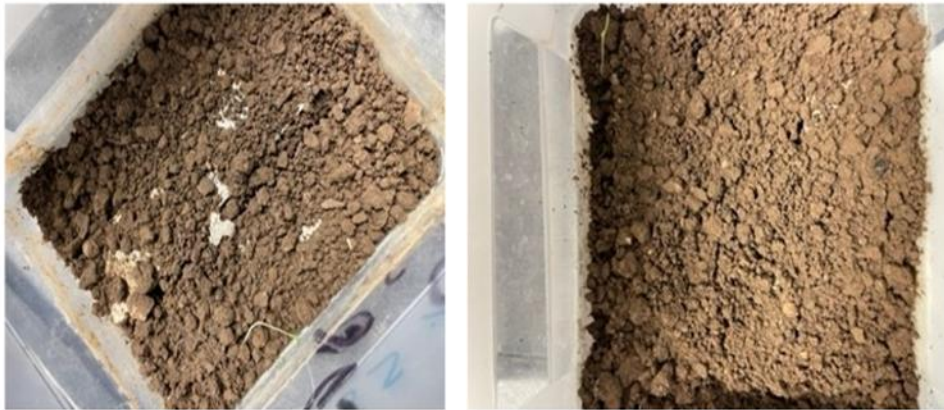
Figure 94: Prisms inside containers immersed in the soil

A sieve test, performed in accordance with BS EN 933 standards, was used to analyse the Particle Size Distribution (PSD) of the natural soil. Mortar specimens were divided into four groups (PW, PO, PN, and PC) and incubated with standard sand in different soil environments for 100 days as shows in figure 94. These environments included plain mortar in water (PW), mortar with nutrients in organic soil (PO), mortar with nutrients in natural soil (PN), and mortar with nutrients in a composite of organic and natural soils (PC). All specimens were kept fully saturated throughout the incubation period. Plain mortar specimens served as a control group to assess any natural remediation potential due to continuous hydration. The natural soil, sourced from fields near the University of Derby, was visually classified as a natural alluvial deposit consisting of soft to firm, dark brown silty clay with slight sandy characteristics. This type of clay is known to support a wide variety of naturally occurring bacterial species. The natural soil's pH ranged between 6.60 and 7.45, while the organic soil exhibited a more acidic pH range of 5.34 to 5.60. Following the cracking process, the specimens were carefully transferred into plastic containers. Dry soil was added in two layers: one beneath the specimens and another on top and in between them. Figure below provides an illustration of the specimen arrangement within the containers.
