Geohazard assessment of landslides in south Brazil - Case Study

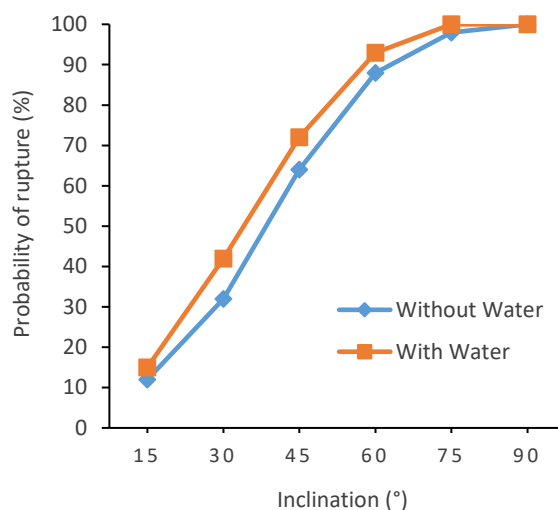
Fig 10. The variation of the probability of rupture (slope failure) using the parameters adopted for Galópolis soil. (based on data extracted from Profil, 2006).

curves versus slope inclination for each type of soil. **Figure 10** shows the results for slopes made of Galópolis soil.

Depending on the slope inclination, three categories of probabilities were defined: (i) High: the probability of slope failure is greater or equal to 50%, (ii) Average: the probability is between 25% and 50%, and (iii) Low: the probability is less than or equal to 25%. The critical slope inclination angles obtained for each type of soil are presented in **Table 5**.

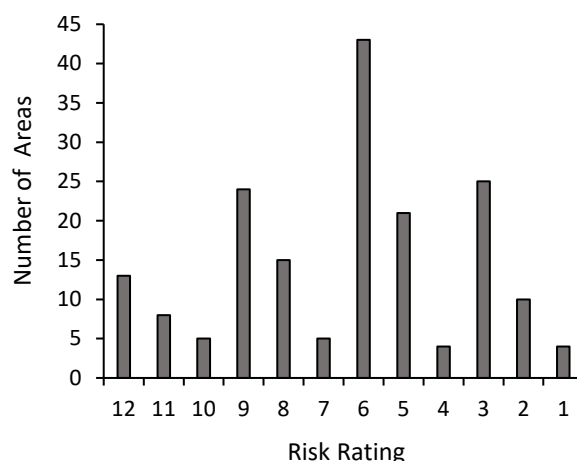
Fig 11. The number of areas identified vs Risk Rating in Caxias do Sul.

The risk assessment identified 184 sites within the urban perimeter of Caxias do Sul, subject to landslides and flood events, of which 163 were considered at risk of landslide, 20 per flood and one suffers both types of risks (Profil, 2006). **Figure 11** shows the number of areas identified for each Risk Rating (from 1 to 12), where more than 60% of the 163 areas affected by landslides have Risk Rating between 6 and 12.
