Case Studies in Engineering Failure Analysis

Root cause failure analysis of a tracked vehicle balance arm

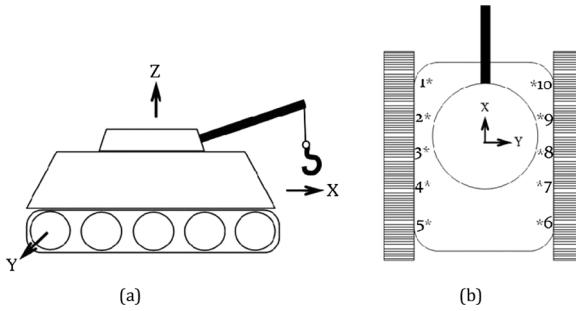
A total of 10 Balance arms were inspected out of which one was found fractured during disassembly (as described earlier). The balance arms assembled in the tracked vehicle with their locations can be visualized in Fig. 6. The remaining 9 balance arms were to be inspected. The Machined portion of these balance arms was the area of interest. The balance Arms surface was prepared by cleaning the area to be examined and area in vicinity to make it free of any dirt, grease, etc. The surface was then dried using a dry lint free cloth before application of penetrant. A solvent removable penetrant type was applied and after a dwell time of 15 min, excess penetrant was removed from the surface. The surface was subsequently allowed to dry by natural evaporation. A Non-Aqueous Wet developer was then sprayed directly onto the surface. A dwell time of 10 min was allowed before starting for Inspection. The balance arms were inspected under a torch light for any surface flaws. 6 out of 9 balance arms were found with cracks. The crack lengths were directly measured for evaluation [10] by tracing the path of flaw formed due to the penetrant and developer application. The cracks were formed at multiple locations on each balance arm and considering the different lengths, a crack length range was established. The summary of these balance arms along with crack lengths and part numbers are presented in Table 5. The maximum observed crack size was 45 mm in balance arm with part number 7127.

Fig. 6. (a) Coordinate system; (b) balance arm assembly locations.
