## Technical paper: Validation of electrokinetic stabilisation of M5 Junction 7

7 January, 2019

D Alder and J Lamont-Black, Electrokinetic; O Hamza, University of Derby; C Jackson, Jacobs; and C Jones, Newcastle University

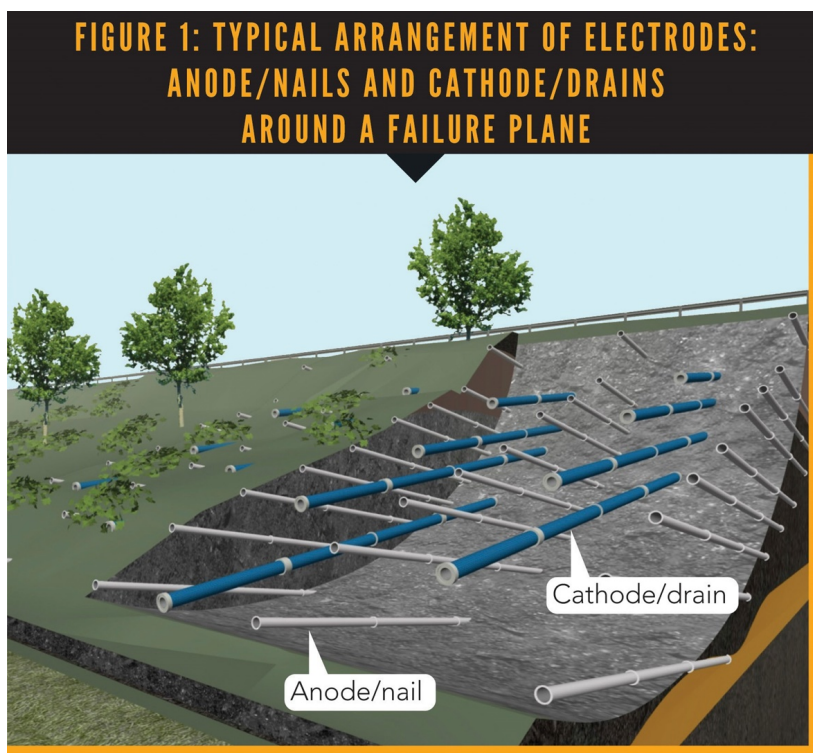
Following EK the anodes are retained as permanent soil nails with enhance soil/nail bond and the cathodes are retained as permanent drains. A typical arrangement of electrodes as anode/nails and cathode/drains in a failure plane is illustrated in figure 1.
